Subject: Department of Natural Resources Washington Geological Survey,
School Seismic Safety Assessment Project, Contract No. AE 410 -
Seismic Evaluation for **Concrete School District**

School Buildings Evaluated in the Concrete School District

Table 1-3. Identified Structural Seismic Deficiencies for Concrete Concrete High School Main Building

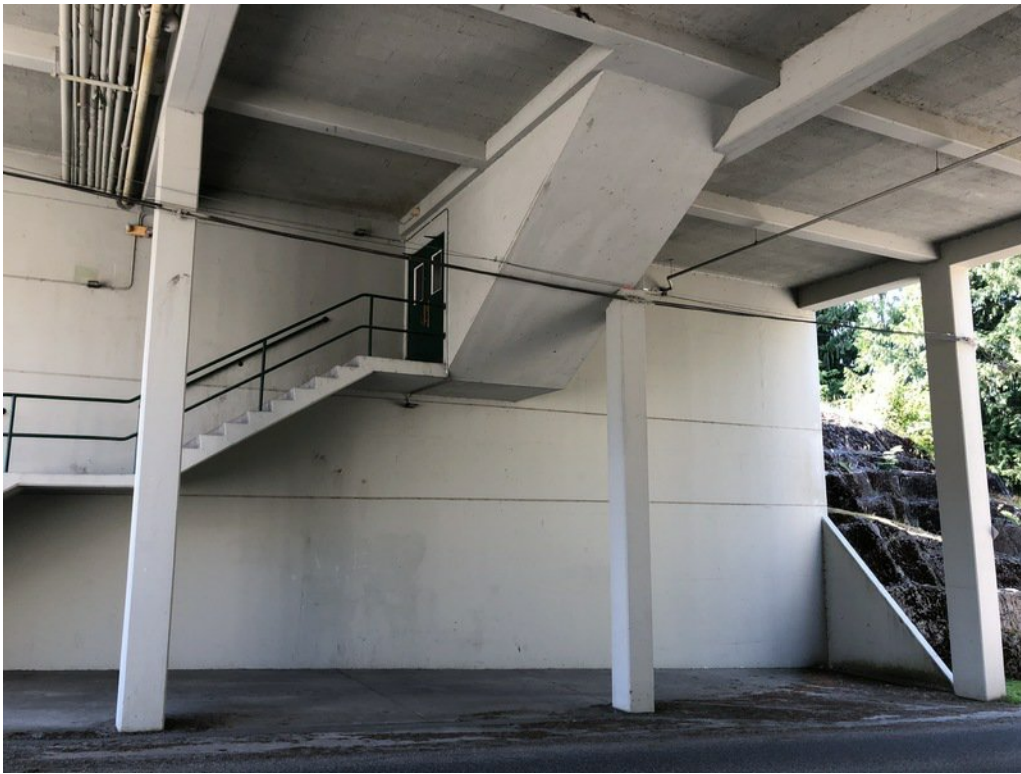
Deficiency	Description
Vertical Irregularities	The shear wall above the road (library) is not continuous to the foundation. Shear wall and supporting framing may require strengthening to mitigate seismic risk.

Figure 1-3. Underside of building span on west side of South Superior Avenue.

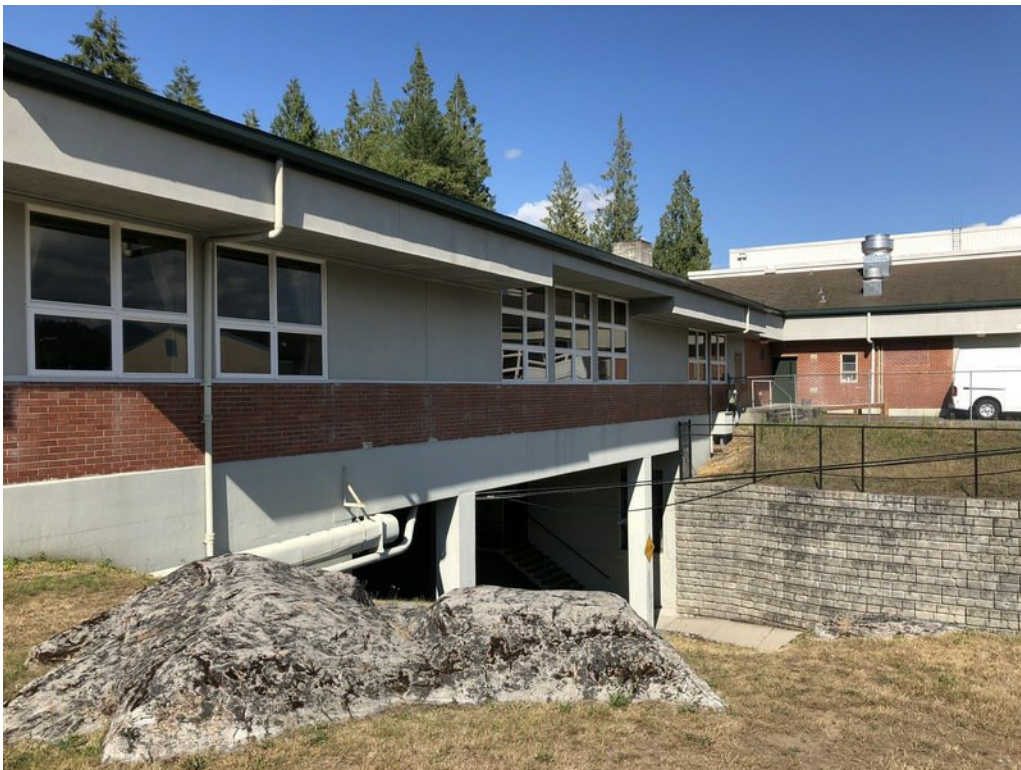
Figure 1-4. Exterior south side of building with building span over roadway.

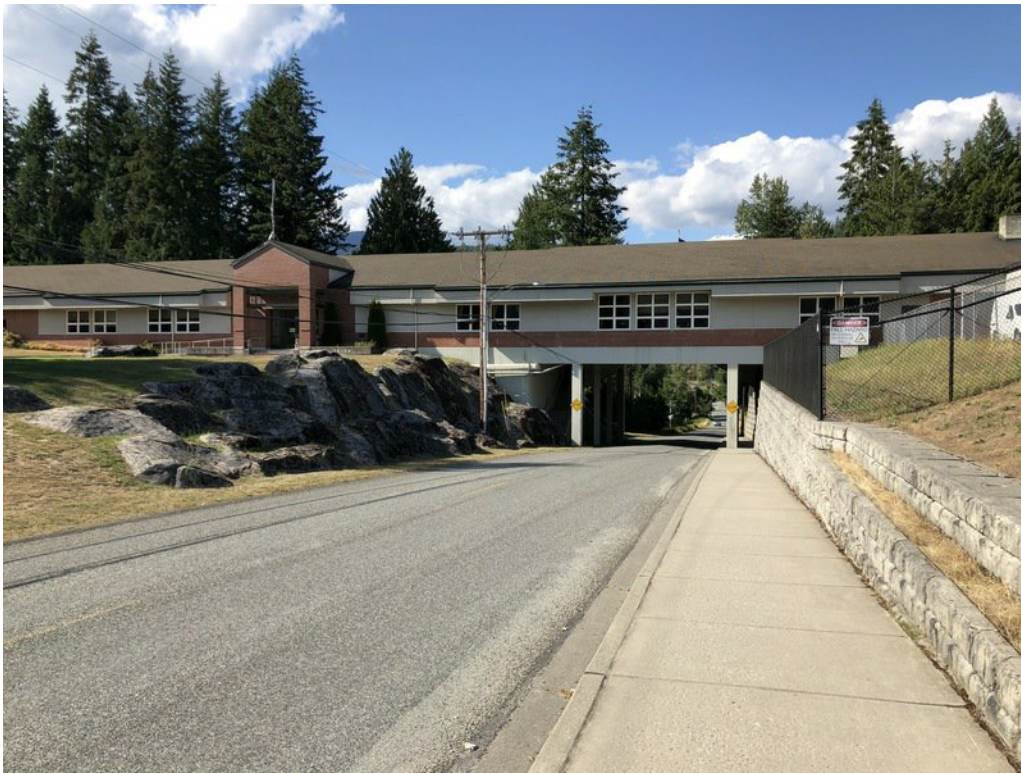
Figure 1-7. Exterior south side of building showing the main entrance and the span across the road.

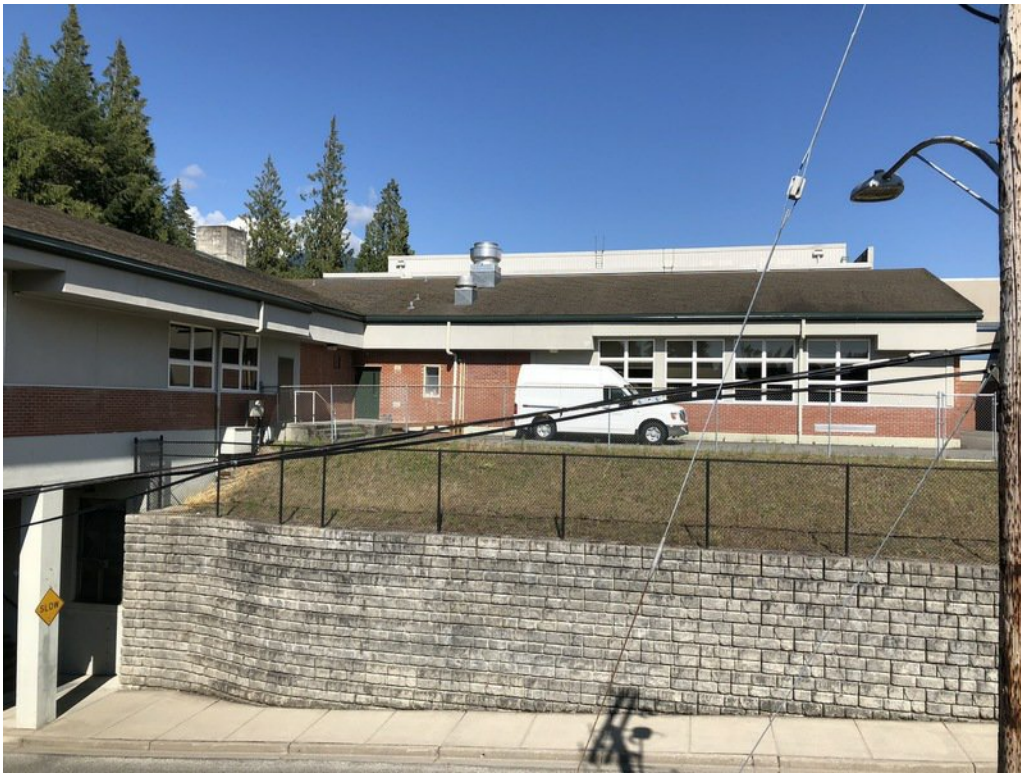
Figure 1-9. Exterior west side of building with the retained soil adjacent to the road.

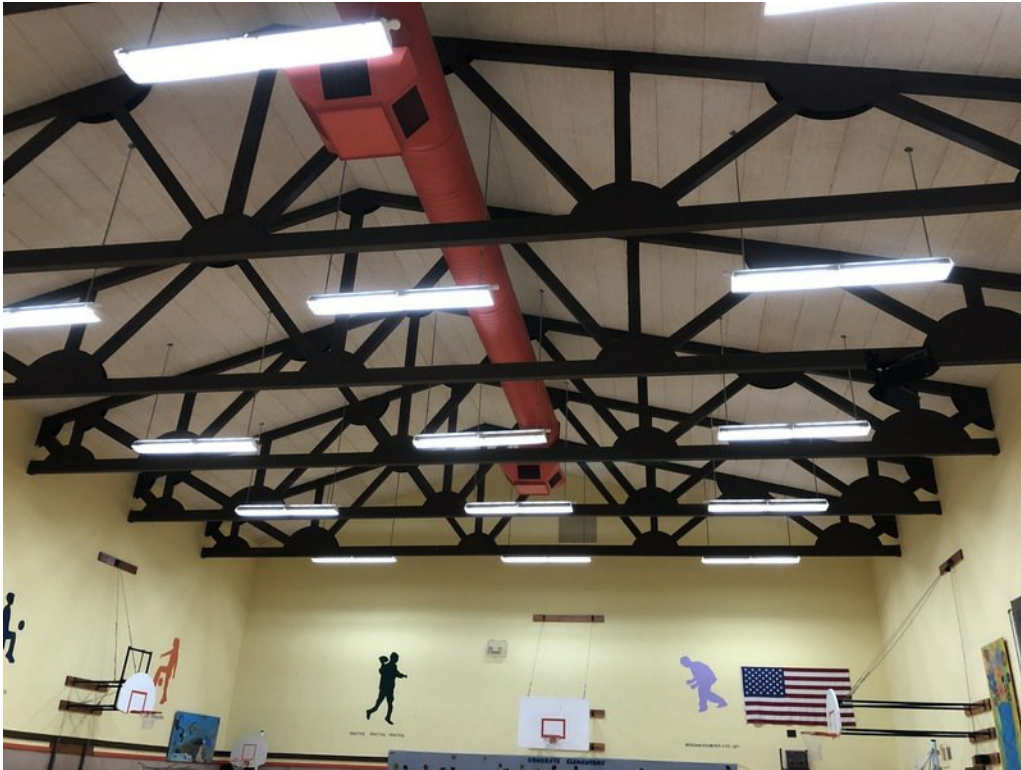
Figure 1-1. Interior of gym. Note glulam wood truss roof system.

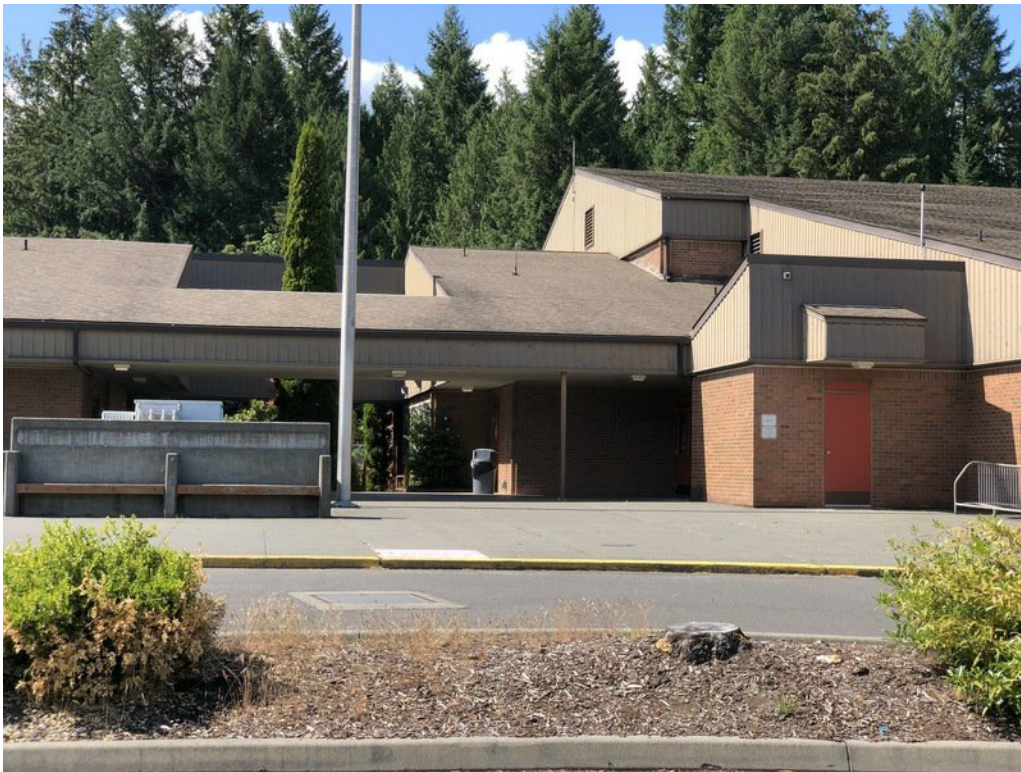
Figure 1-7. Exterior south side of the diaphragm connection between the main building and the gym building.

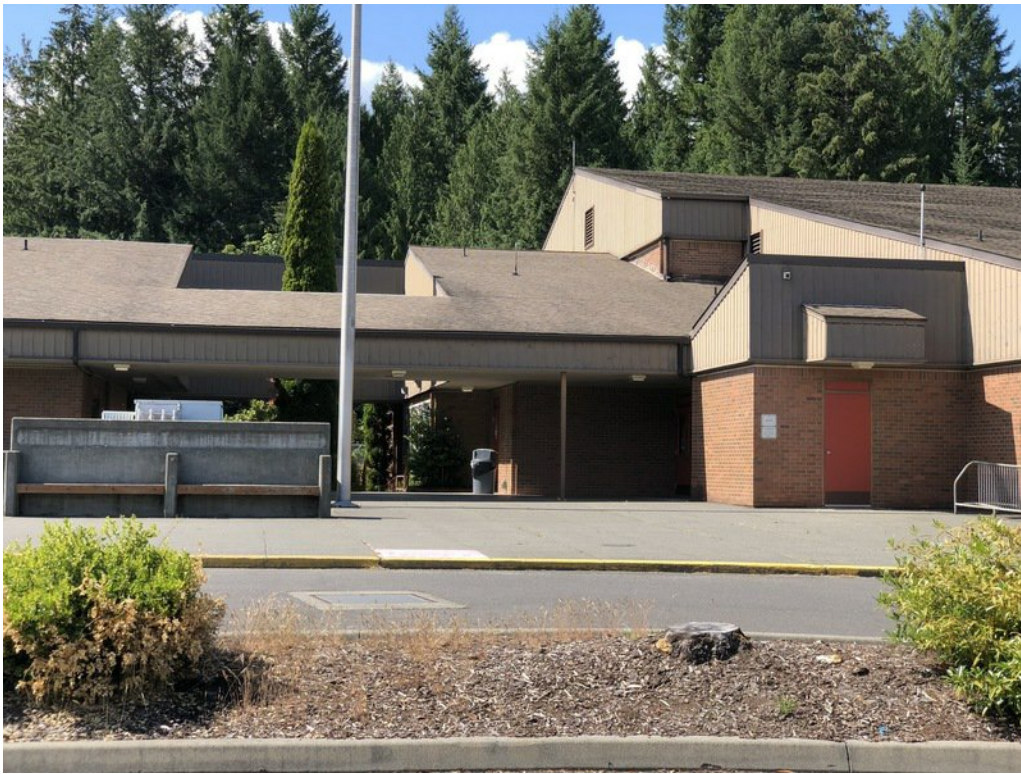
Figure 1-7. Exterior south side of connection between the main building and the gym building.
